# Manhole Inspection Summary

## Manhole # S11II1033MH

Insp Date: **11/25/08 9:23 AM**

**Location** Address: **4501 INTERSECTION PARK HEIGHTS** Cross Street: **WYLIE AVE**

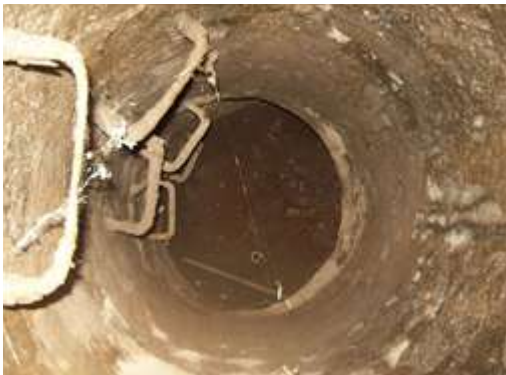
Defect 2

Condition: ☐ Sound ☐ Cracked ☐ Root Intrusion ☐ Deteriorated ☐ Leaks ☒ **Debris**

NOTE- NO CHANNEL , DEBRIS ON BOTTOM

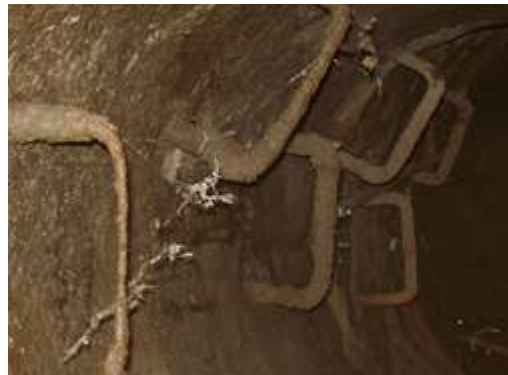
Defect 1

**Steps** Count: **6** Missing: **0** ☒ **Corroded**

corroded steps

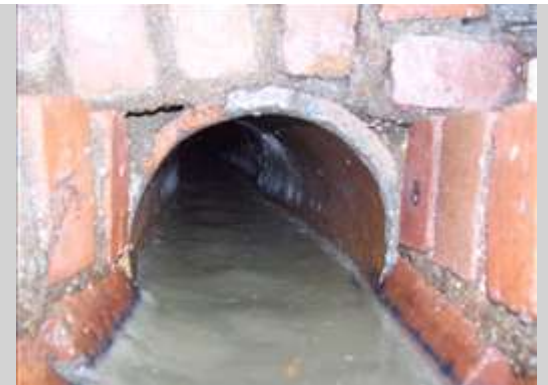
3 O'Clock Inflow

8 in. Circular Gravity Sewer  
Pipe In @ 3 O'Clock

Infiltration: **None** Pipe Seal Cond: **Cracked**
